## Great Cyclone

## 13 Factsheet 2: Coastal inundation (storms

## Cyclone Bola 1988

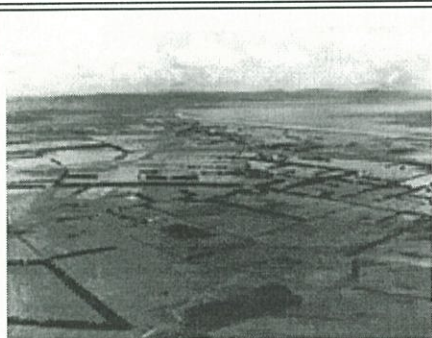
An aerial photograph of the flooding over the lower Hauraki Plains over the fourth to fifth of May nineteen thirty eight.

Two years later, on 4–5 May 1938, 35,000 ha of the lower Hauraki Plains (pictured) were flooded through a combination of spring tides

and northeast gales that caused a large storm surge and accompanying waves. There were several breaches of the shoreline stopbank from Waitakarau to Kopu. The inundation was exacerbated by heavy rainfall.

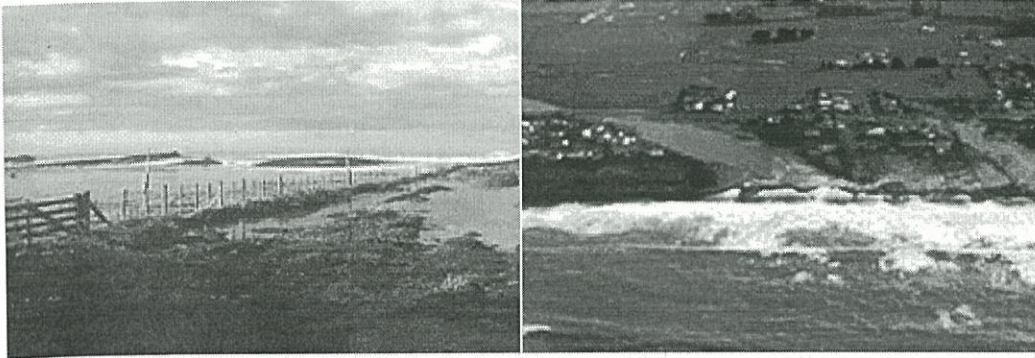
Photographs showing the gravel barrier being overwashed at East Clive on the 16 August 1974. The photograph on the left is taken from landward of the barrier and shows wave overtopping and flooding of land behind the barrier. The photograph on the right is taken from the air and shows waves also overtopping the barrier and the flooded land behind.

Coastal inundation at East Clive, south of Napier on 16 August 1974 was caused by persistent heavy swell coinciding with high tides. This resulted in the gravel barrier being overtopped and the low-lying land behind being inundated and 200 homes affected.
